# Grove Cottage

An advanced refurbishment case study

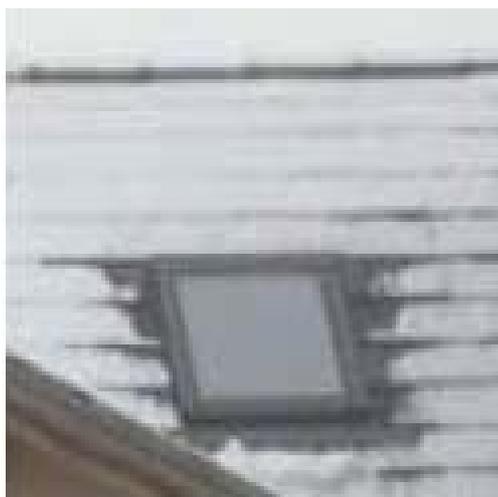
Figure 31: The impact of thermal bridging around rooflights is shown by melting snow

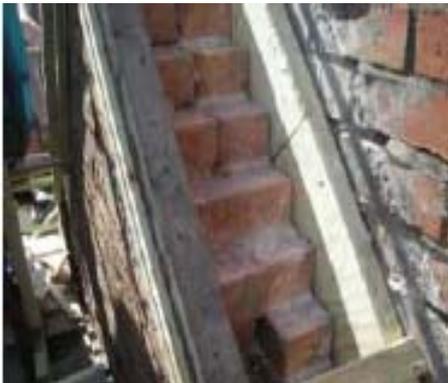
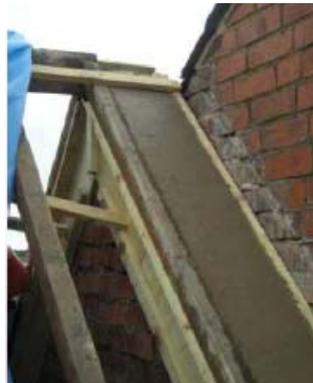
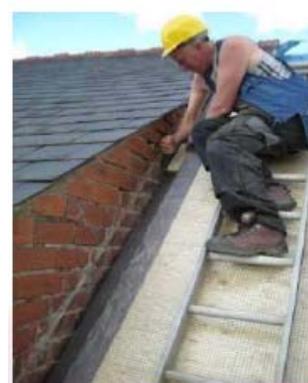
Figure 42: Cement used to consolidate top of gable wall, ready to receive air-vapour barrier

Some unexpected work was nevertheless required; for example, the repair / rebuilding of the top of the gable wall (shown in figures 41 – 43), which was mainly prompted by the need to create a structurally sound gable end for the airtightness membrane to work to, in order to ensure a robust and durable result.

Figure 43: Sealing the roof air-vapour barrier to the top of the gable wall, using bitumen tape

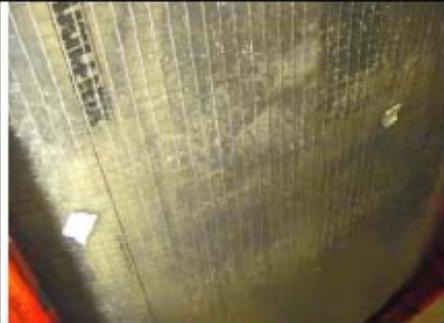
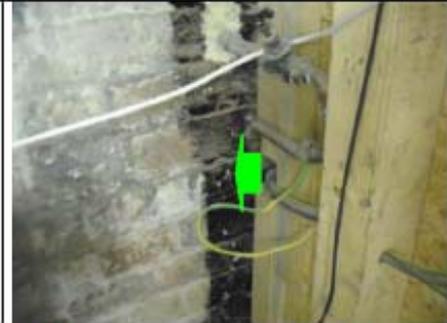
<p>Putty patches to holes through membrane at base of access stairs to basement.</p>		<p>Leakage in basement in places between timber framing and brick front wall, also around service penetration.</p>

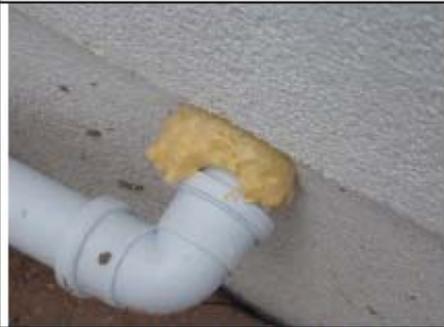
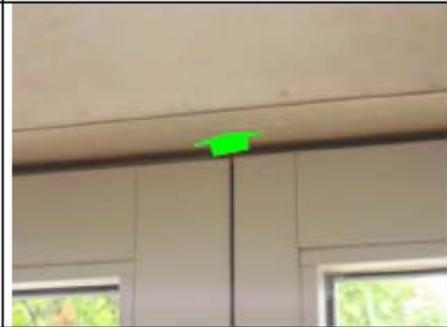
<p>Expanded foam last minute sealing around waste pipe from kitchen – to be cut back and mastic over-sealed for a neat &amp; airtight finish.</p>		<p>Some leakage across head of rear double door – to be adjusted.</p>

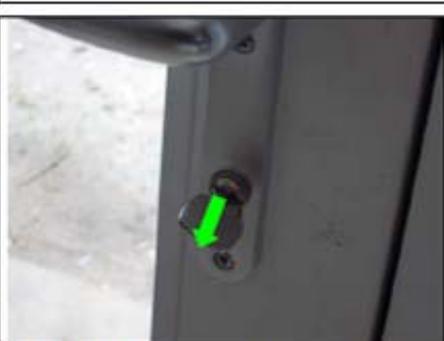
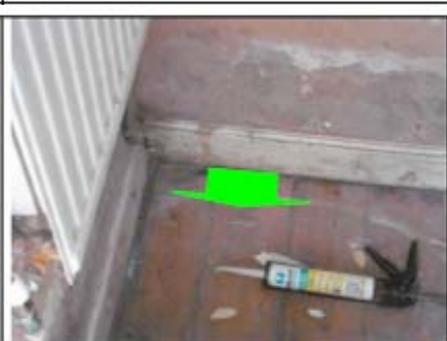
<p>Air leakage through lock, even with key in place!</p>		<p>Leakage along bottom of skirting on party wall, connecting to unfilled cavity between dwellings – to be further reduced.</p>

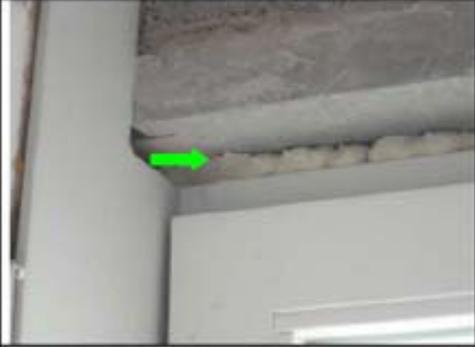
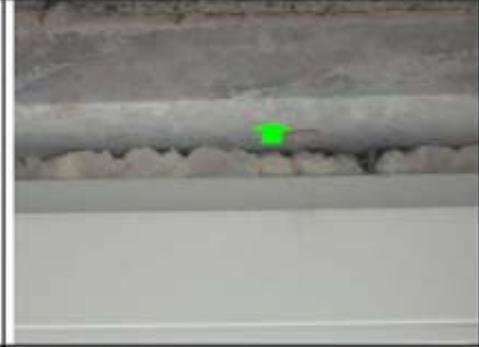
<p>Leakage through gaps behind plasterboard beside entrance door.</p>		<p>Leakage between foam and lintel where plastering above door not yet done.</p>

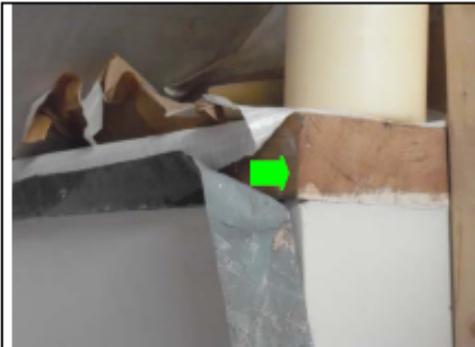
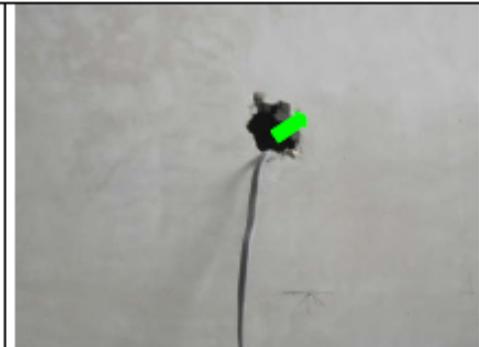
<p>Minor leakage at wall/ ceiling corner in upper bathroom, at complex junction of internal and external air barriers.</p>		<p>Minor leakage through service void entering dwelling around cable.</p>

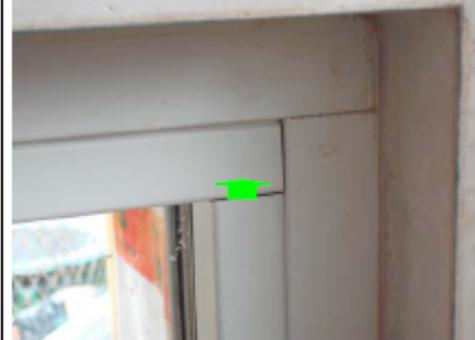
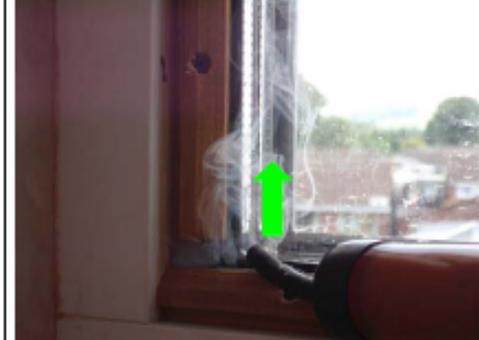
<p>Minor leakage at joint in window frame.</p>		<p>Leakage in corner of high level window.</p>

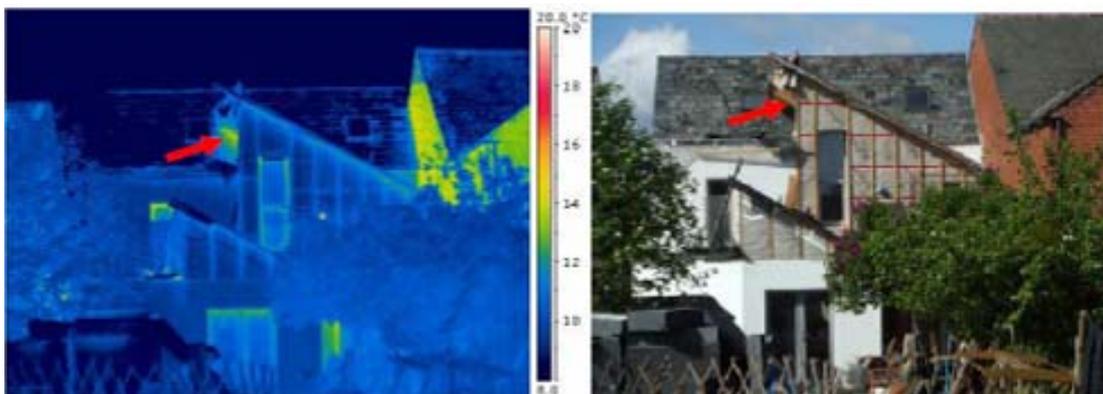
Figure 52: Thermographic image showing rear of Grove Cottage

Figure 52 shows elevated temperatures (indicated by the arrow) under the eave of the extension roof at the junction where it meets the main cottage roof. This was investigated and found to be caused by a glazed unit that had not been fully sealed to its frame. The unit was subsequently sealed as specified.

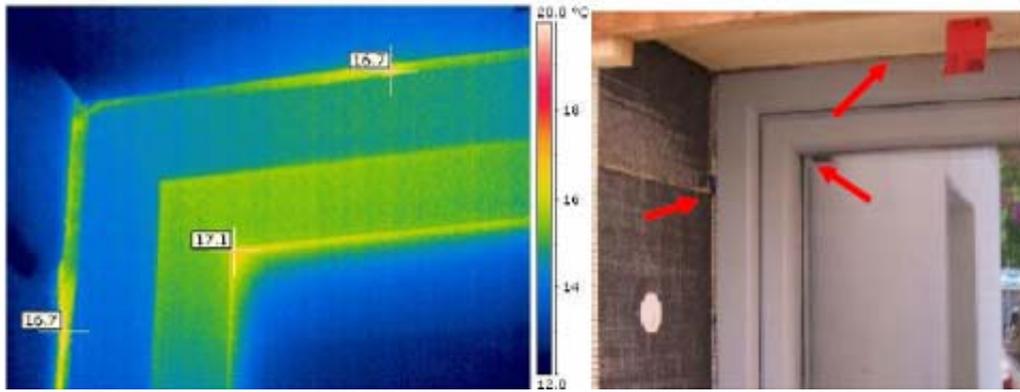
Figure 53: Back door, next to WC

The temperature gradients identified around the door frame were felt to be excessive and in need of further investigation. As similar effect was identified around the WC window (see figure 54). It was established that at the time of the test, the final layer of insulation had not yet been fitted to the windows and doors in the 'Larsen Truss' area of the wall. The final detail will include a 50mm foam board which overlaps the frame by 40mm, to be applied to all soffits and jambs of windows in the trussed walls; this should reduce such heat loss significantly.

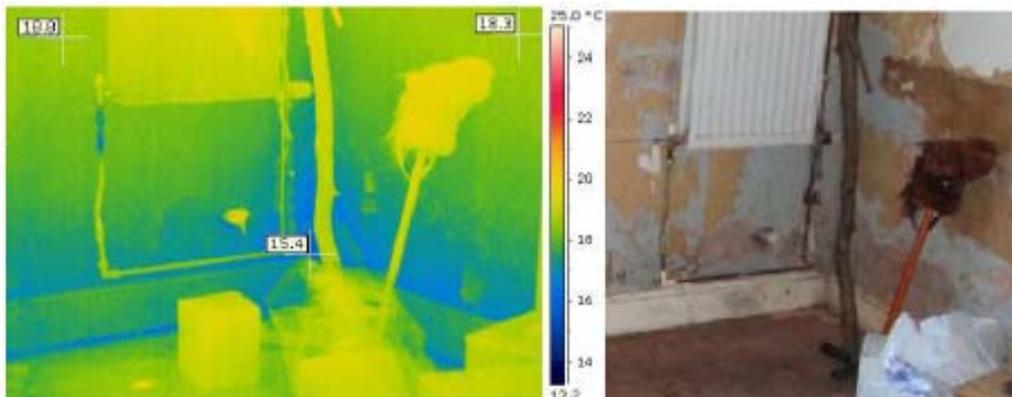
Figure 55: Cold corner at junction of front and North ('party') walls.

Figure 55 shows a corner which is noticeably cooler than its surrounding wall. This was investigated and found to be due to an area of the 25mm cavity between dwellings that had not yet been filled with foam. The heat loss was exacerbated by a recessed telescopic air vent below the window (not visible in figure 55), that remained within the wall, effectively creating a void within the insulation.
