Results

Grove Cottage

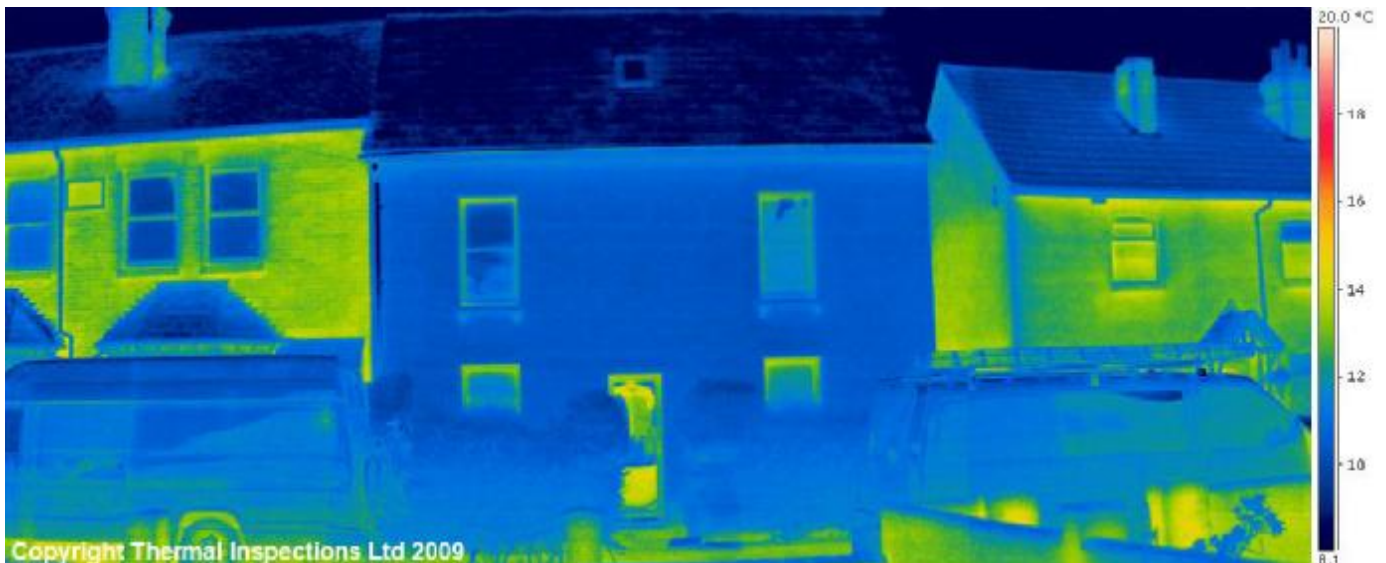
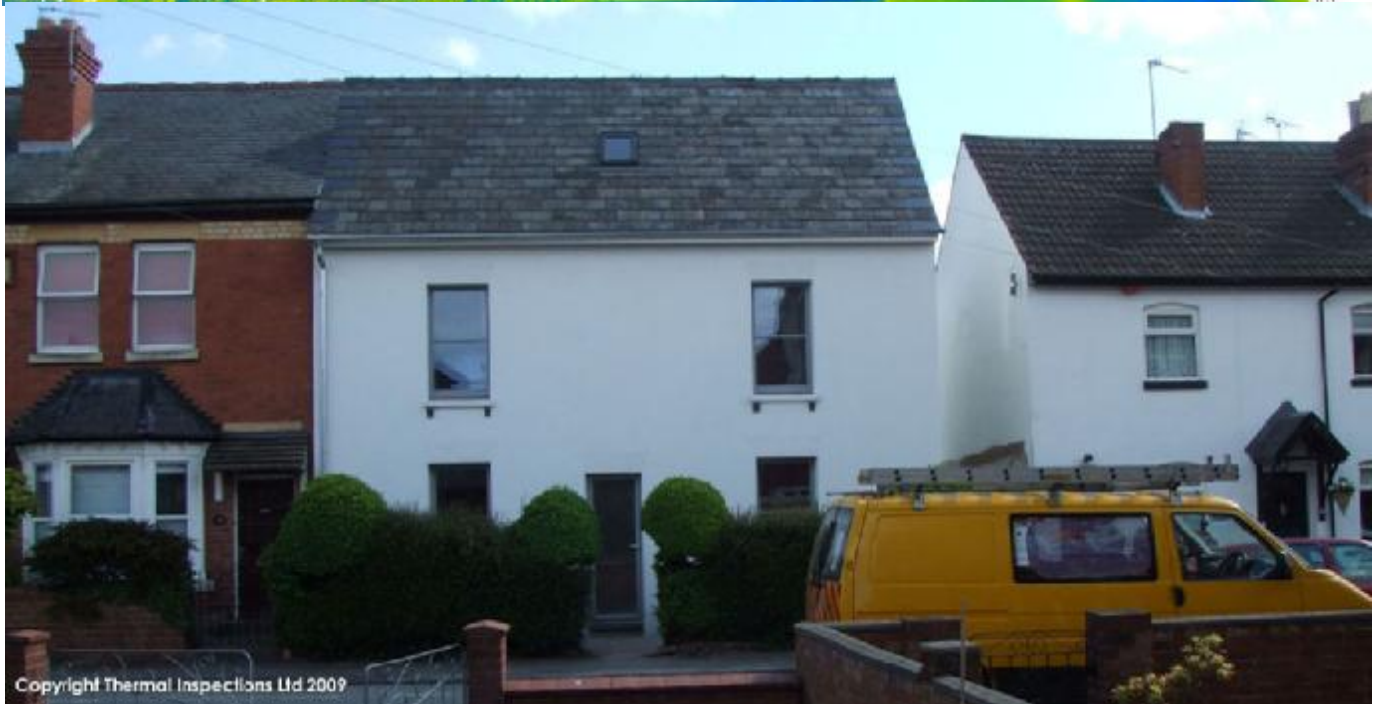
Thermogram 1 – Front

No noticeable heat losses.

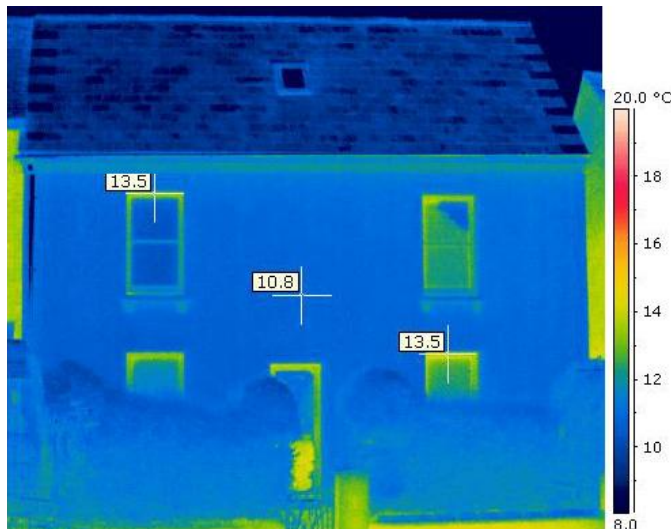
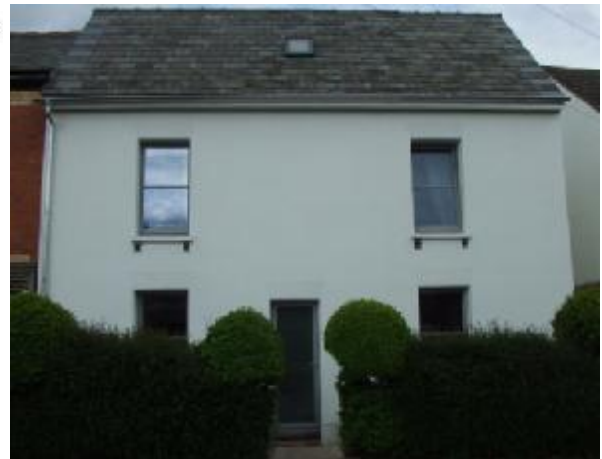
Thermogram 2 – Front

No evidence of thermal bridging or any other heat losses. The 'warmer' window frames are due to the shielding effect (shielding is when a surface is not affected by exposure to the cold night sky, this can make it appear warmer than the surrounding surfaces).

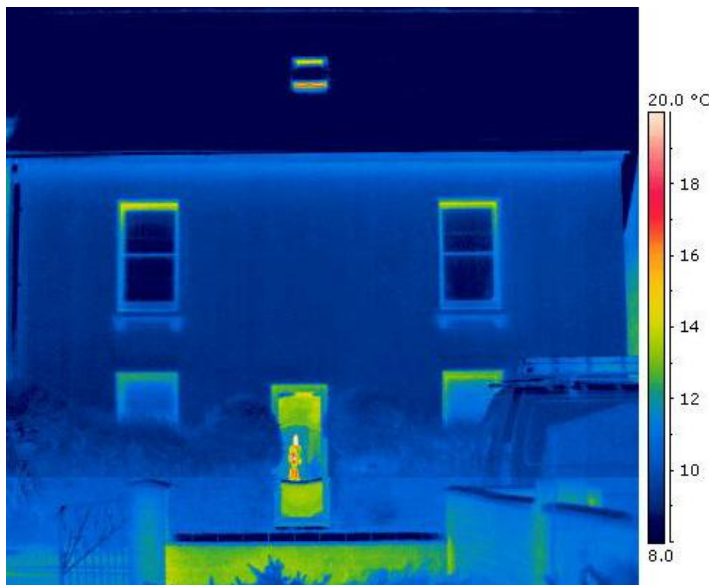
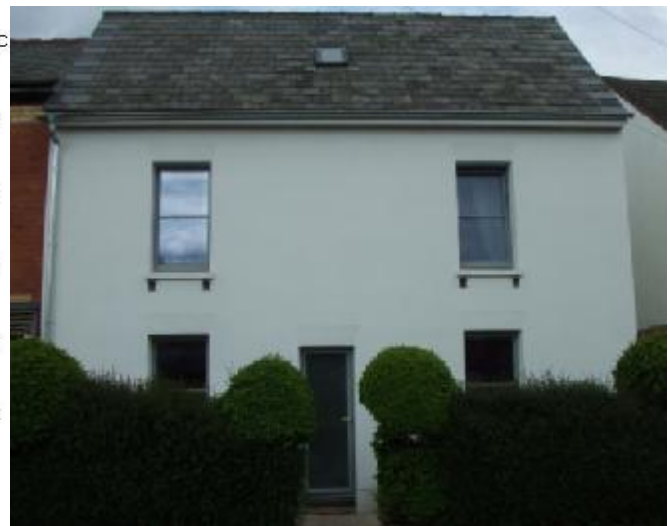
Thermogram 3 – Front

Here we can see the roof window and upstairs windows were now open. Ignore the reflection in the front door.

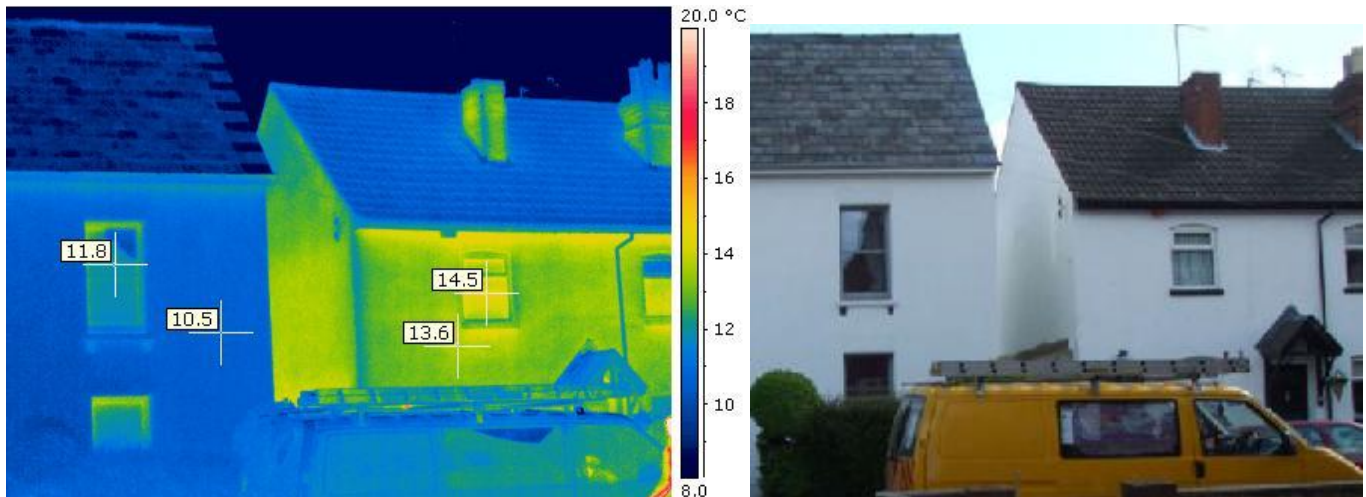
Thermogram 4 – Front, SE neighbour

Neighbour's house (right) and Grove Cottage to the left. Without further investigation of the neighbour's house it is hard to say if the warmer surface temperature is due to the wall material, lack of insulation or a combination of both these factors.

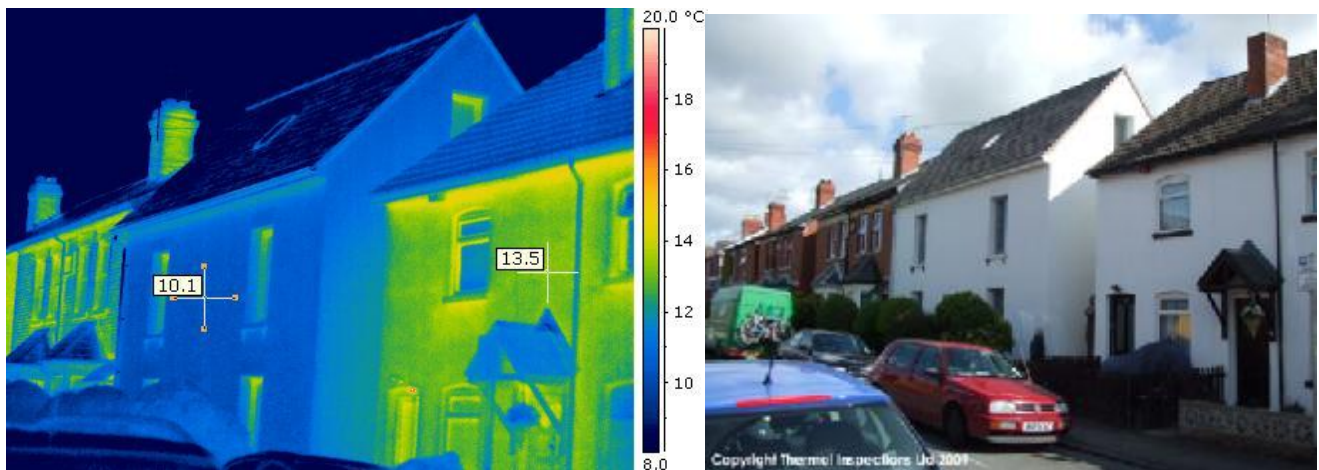
Thermogram 5 – Front, street view facing NW up Portfield street

Front wall of the neighbour's house is 3.5 C warmer than Grove Cottage, this is significant and likely due to lack of insulation however this cannot be confirmed by this thermogram alone.

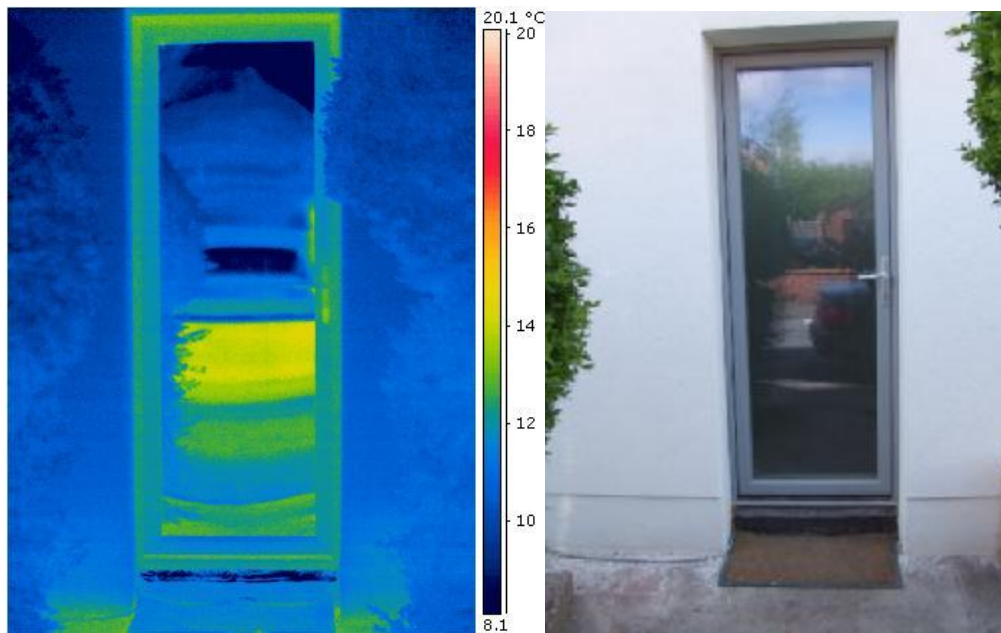
Thermogram 6 – Front door

The yellow 'warm' patch in the door is just a reflection of the wall on the other side of the road. The 'warmer' top of the door frame is due to shielding from the sky, and no cause for concern.

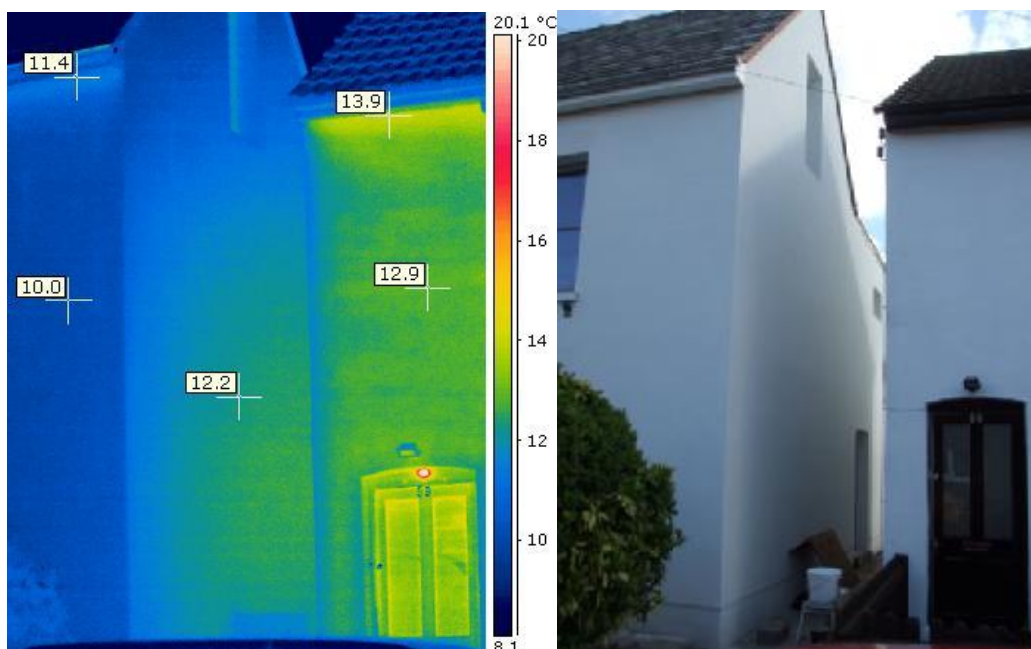
Thermogram 7 – Gable end wall of Grove Cottage

No anomalies. The gable wall most likely shows as slightly warmer due to shielding from the sky, and infra-red reflection from the neighbour's wall opposite.

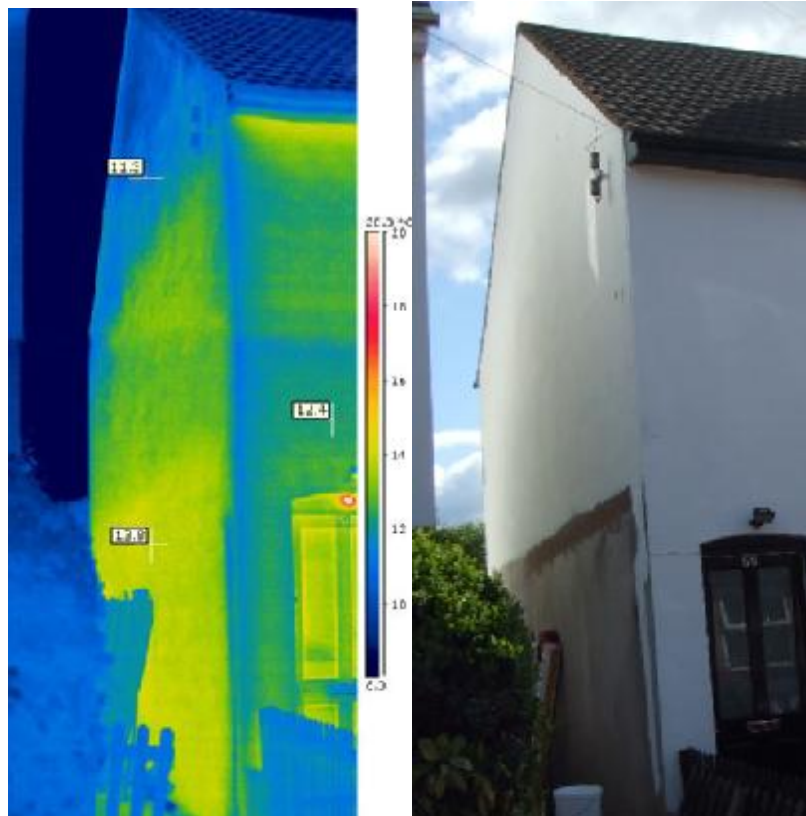
Thermogram 8 – South neighbour, Gable end wall

The green/yellow area is 13+ C which at first glance seems to indicate conductive heat losses through the wall. Shielding may also play a part in showing an increased temperature as we see the higher part of the wall appears cooler, being more exposed to the sky. This 'warm' area seems to stop in a uniform line at about loft level, this could indicate an insulated loft, and solid walls.

If this neighbour's wall is solid, and no insulation exists then this would account for the increase in temperature compared to the cooler gable wall of Grove Cottage.

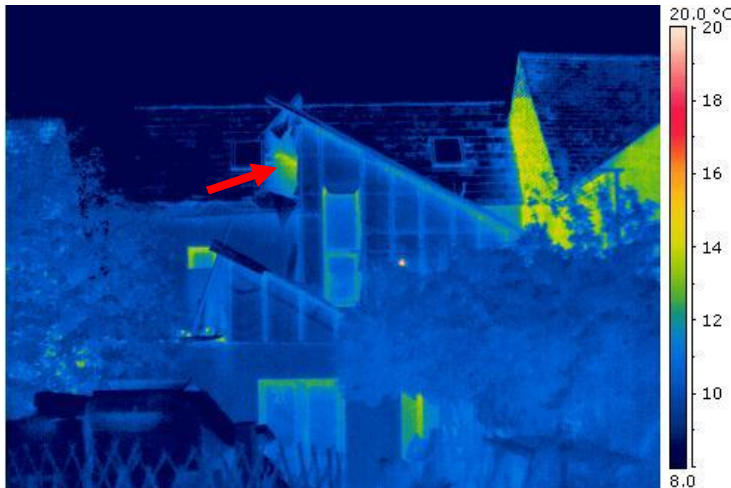
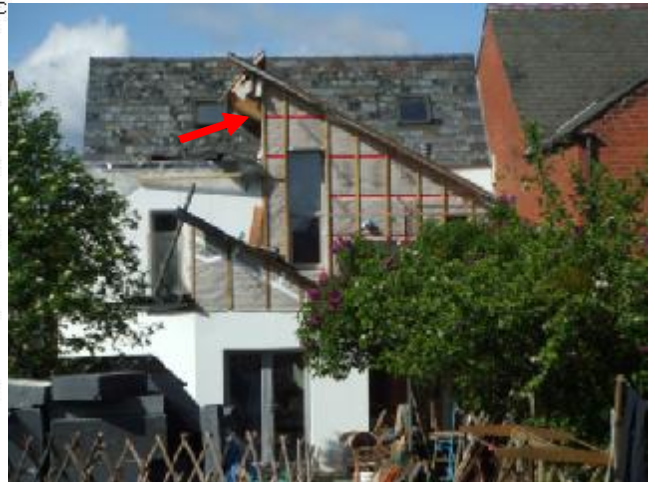
Thermogram 9 – Rear of Grove Cottage

No major issues. Worth investigating the elevated temperature indicated by the arrow underneath the eave of the extension roof where it meets the house roof.

fixed window: glass glazing unit was not actually finally sealed to frame during this survey (had been forgotten during works).
Unit was later sealed to frame as specified - during later air pressure test no significant air leakage observed.

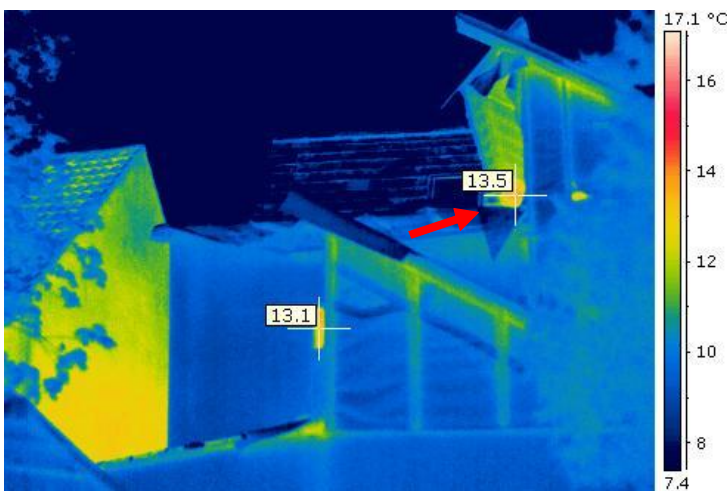
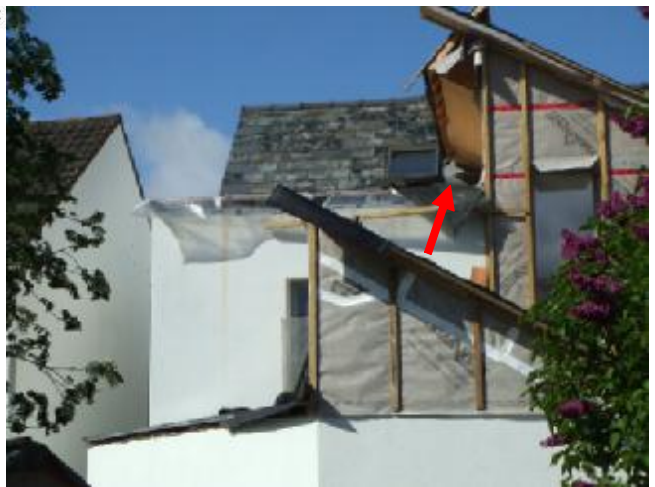
Thermogram 10 – Rear, first floor

The hotspot on the roof (13.5 C) should be investigated as no immediate explanation could be found (same anomaly as previous Thermogram 9). The window frame (13.1 C) appeared warmer than expected due to shielding only.

As above.

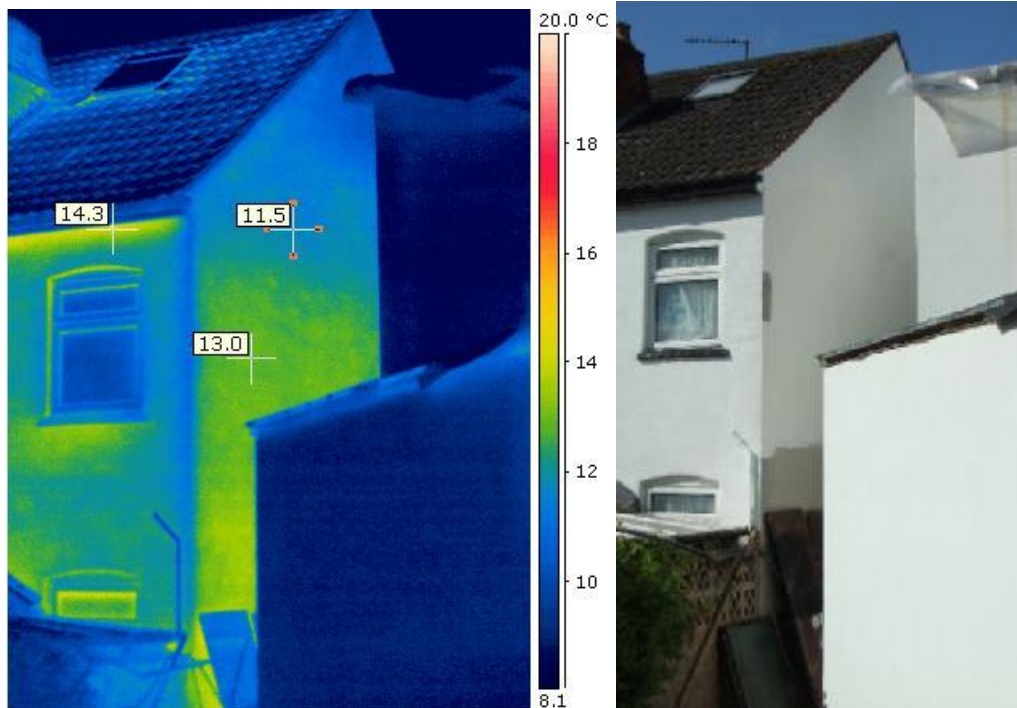
Thermogram 11 – Rear, South neighbour, gable wall

Underneath the roof eave there may be some air leakage and the elevated gable wall temperature can be seen from this angle too. Grove Cottage shows none of these temperature elevations.

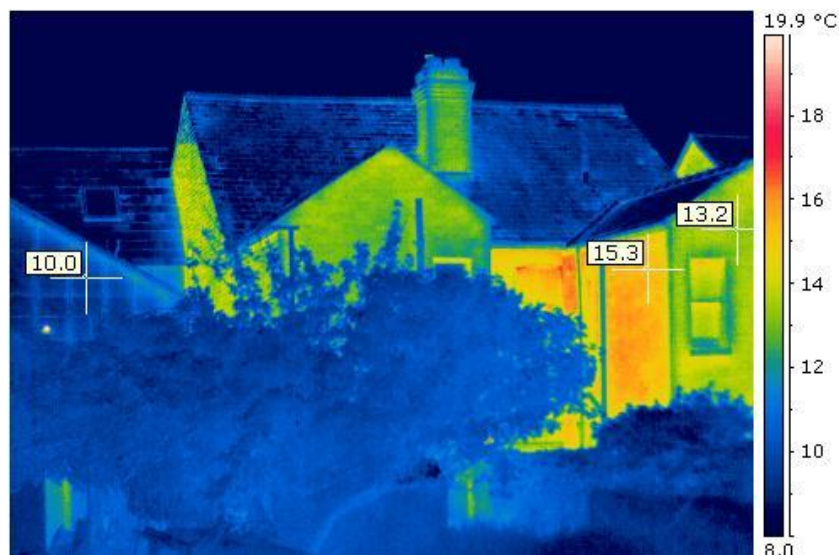
Thermogram 12 – Rear, North neighbour

The difference in surface temperature between the three properties is obvious, Grove Cottage is to the far left (10 C)

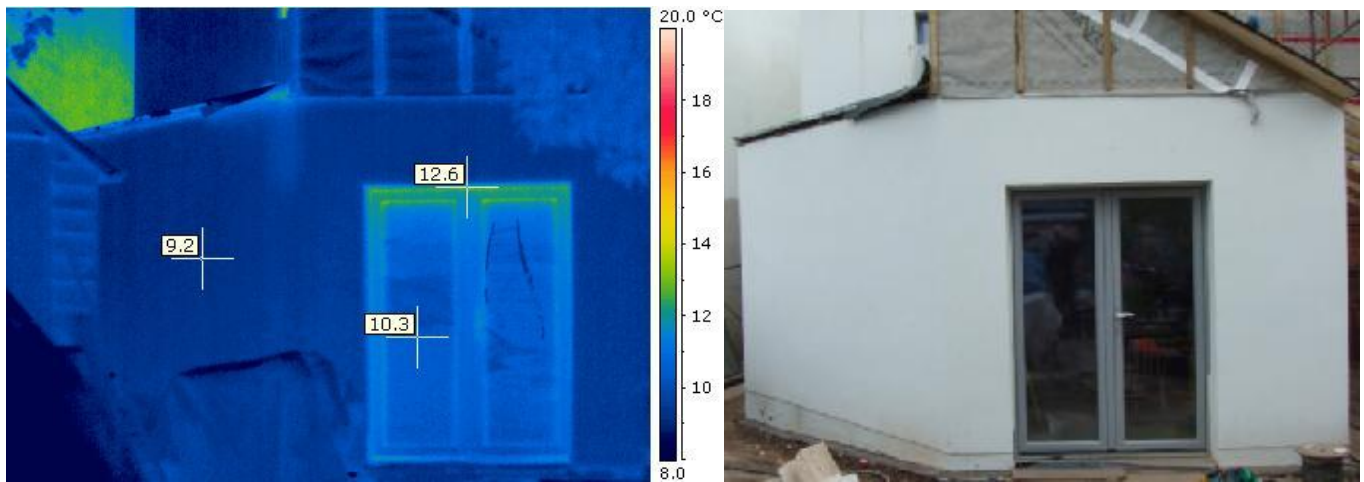
Thermogram 13 – Rear of Grove Cottage, kitchen doors

As the doors are recessed, the frame is shielded from the cold night sky and therefore appears warmer. No issues.

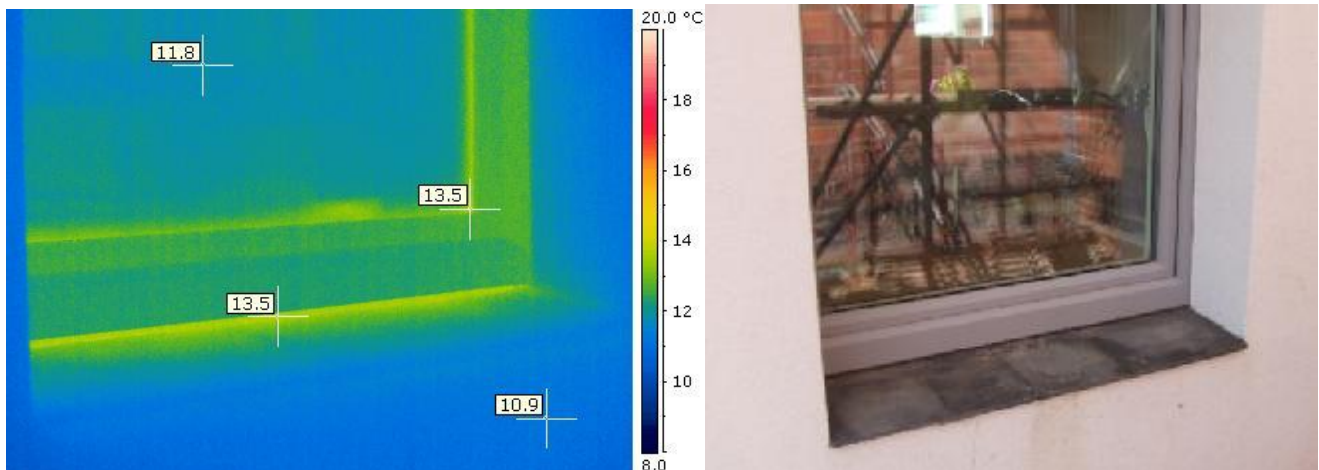
Thermogram 14 – Kitchen window, NW wall

This shows the 'warmer' parts of the window, however, these are due to shielding from the sky and not considered heat losses.

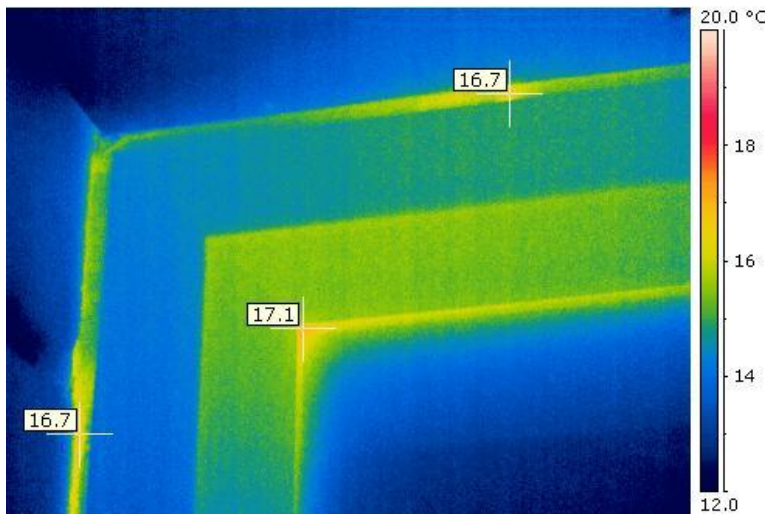
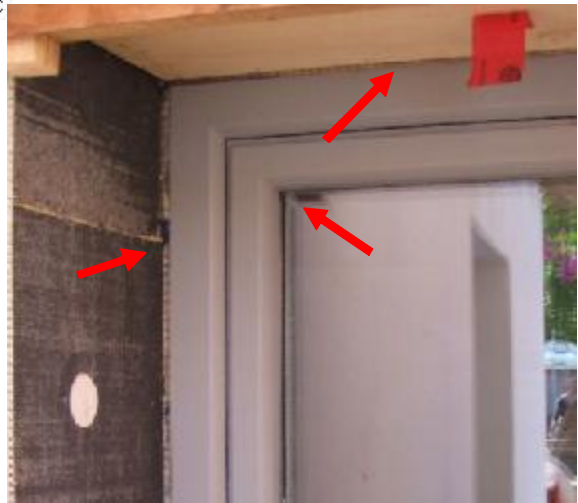
Thermogram 15 – Back door, next to WC

The temperatures marked with the crosshairs were excessive and would indicate heat losses around the frame. Investigate.

The final layer of insulation (insulated soffit and jamb detail) has not yet been fitted to windows in the 'Larsen Truss' areas of wall: this will be a 50mm thick foam board overlapping the frame by 40mm. This will be applied to all soffits and jambs of windows in the Larsen Truss walls, cutting out this heat loss.

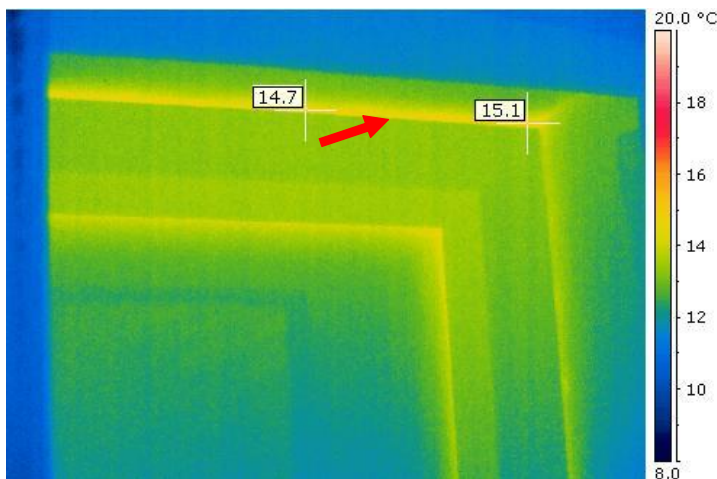
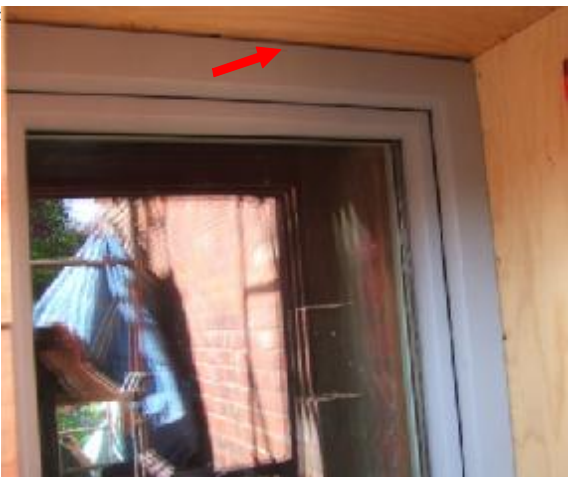
Thermogram 16 – WC window, top half

Would be worth checking the seal around this frame.

is not leat loss from air leakage - see above.

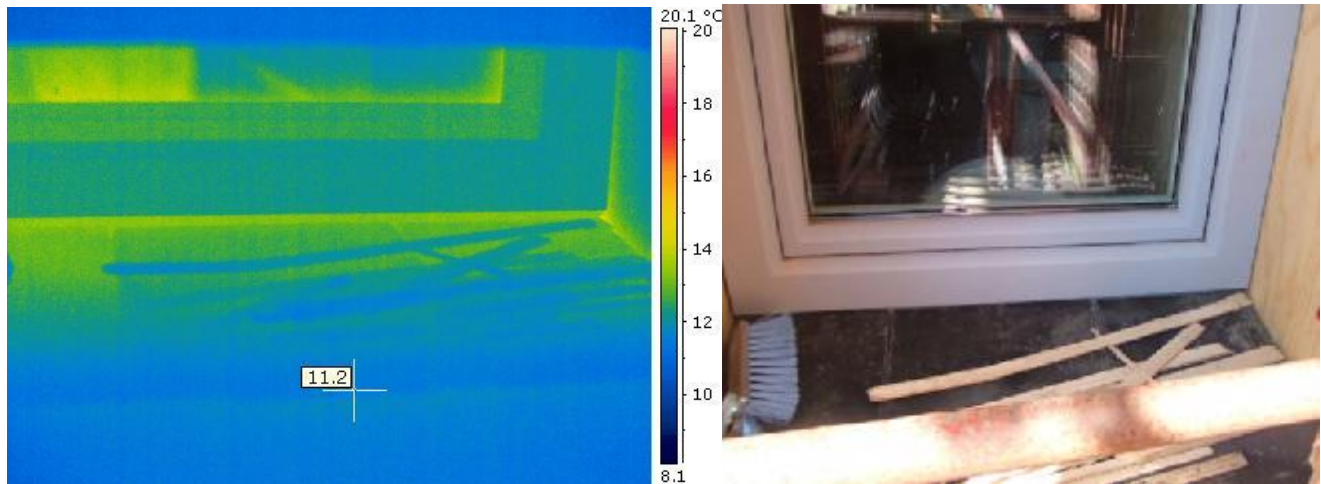
Thermogram 17 – WC window, lower half

No issues here.

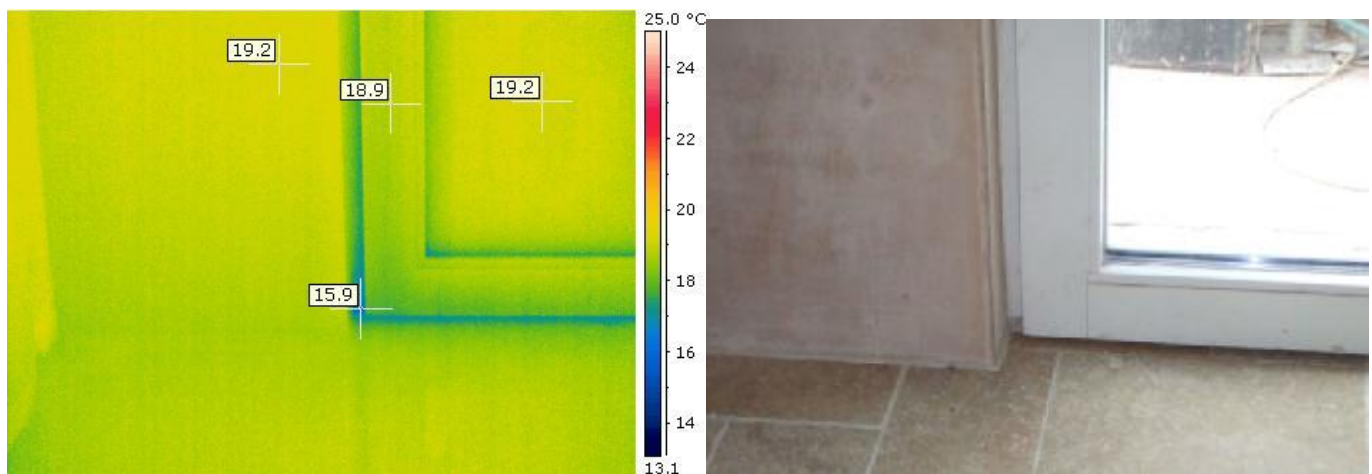
Thermogram 18 – Hallway door, on gable wall

The lowest temperature is still above the dew point. No issues.

There are some minor issues with air leakage along threshold seals of all doors. A final adjustment of the doors and windows will be carried out by Internorm UK to ensure best adjustment - this should reduce the air leakage at this point. NB air leakage result was an air permeability of 0.97m³/m²hr and 1.0 ac/hr (see www.simmondsmills.com for full air pressure test report)

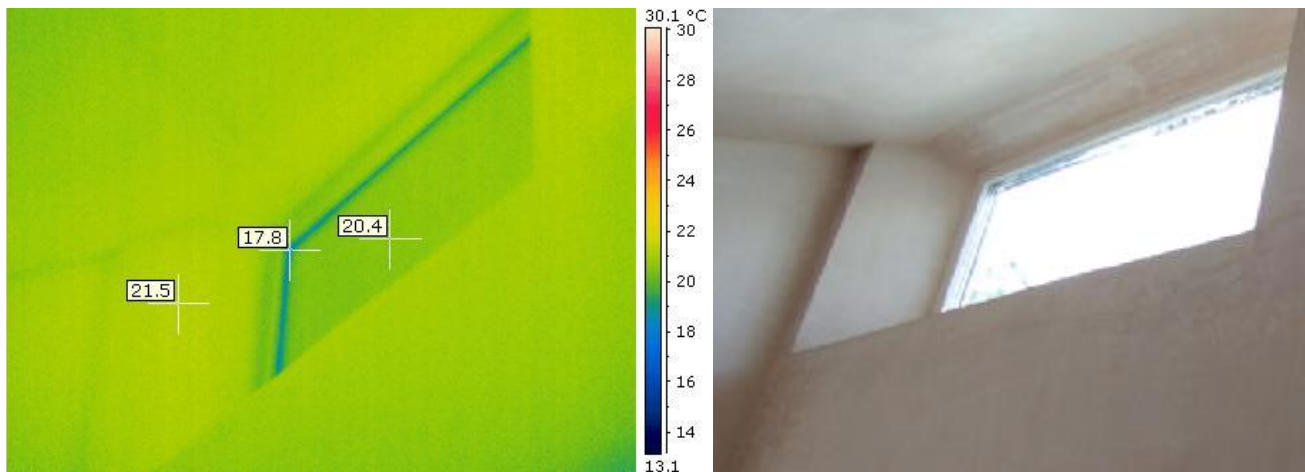
Thermogram 19 – Kitchen ceiling window, closest the double doors

A wider temperature span has been used for this image as the ceiling area of the kitchen was warmer due to rising heat. The window is cooler where the glass meets the frame, however at these temperatures this would not generally be considered a defect.

This image should be discussed with the thermographer to clarify.

Internorm Uk are to check glass to frame seals on fixed lights to check instalation.

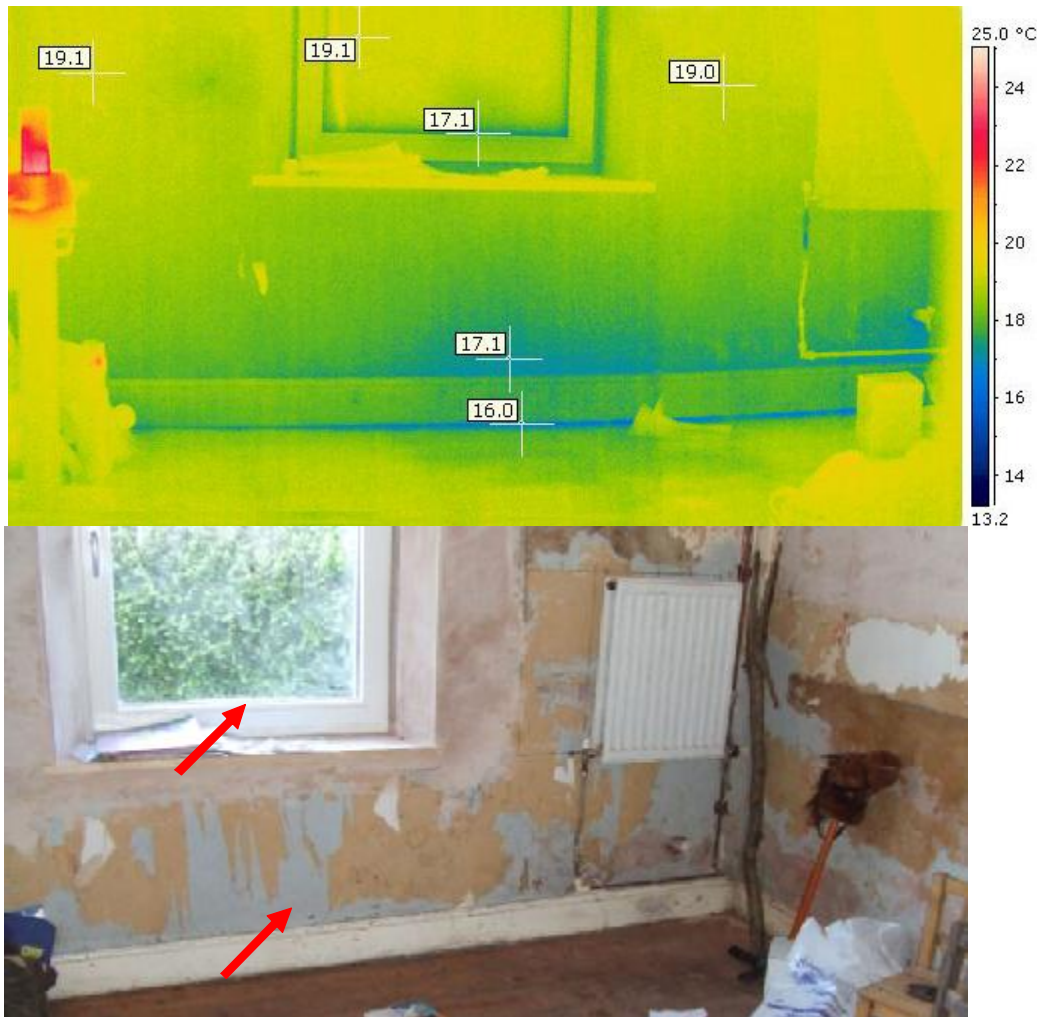
Thermogram 20 – Play room, SW wall, front wall of house

The wall and window **above** window frame level are at 19C, however this drops to 16C where indicated by the blue colouring and crosshairs. Andy Simmonds said this was acceptable and due to a vent on the outside of the wall. There was also a cold patch on the window (17.1 C crosshair) which could not be explained, although it is the same temperature as the window in the previous Thermogram 19.

Discuss this image with the thermographer to clarify.

Corner of room: This area of wall 25 mm cavity i.e. north gable 'party' wall adjacent to neighbours house has not yet been filled with PU foam as elsewhere. When this is complete both the minor airleakage at this point (via the cavity) and also the insulation value should improve, raising surface temperatures at this semi-exposed corner.

Area of wall below window: a fully recessed telescopic air vent (ventilating basement below) in effect has 'removed' a volume of wall insulation at this point, which gives rise to this cooler area.

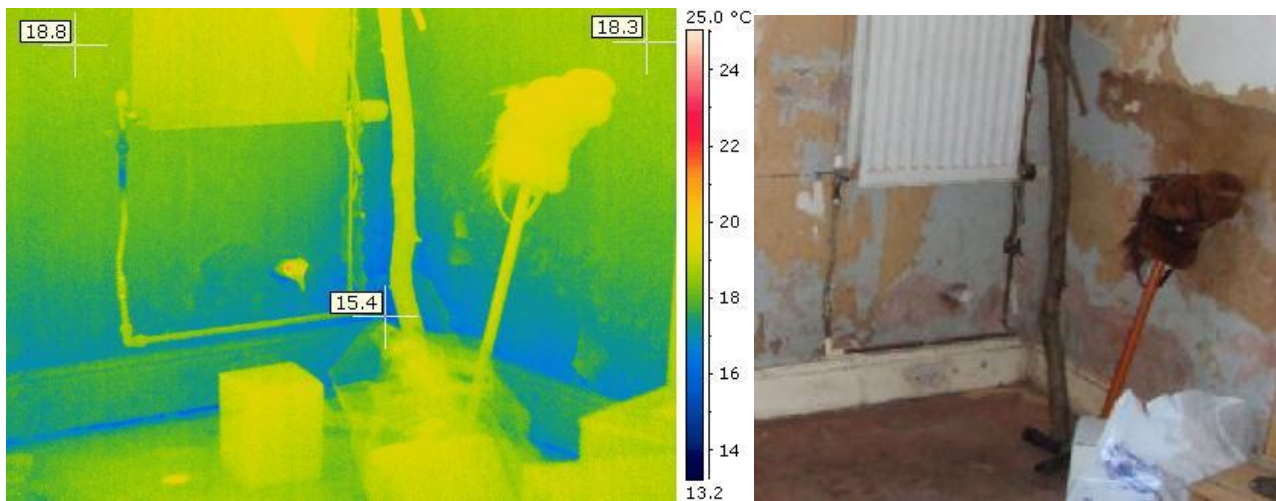
Thermogram 21 – Play room, SW wall, corner

The corner of the same play room wall as previous Thermogram 20. This corner is noticeably cooler but although no obvious explanation for this can be seen from the images, Andy Simmonds suggests this is still above the dew point and no cause for concern.

As above.
