# Grove Cottage

An advanced refurbishment case study

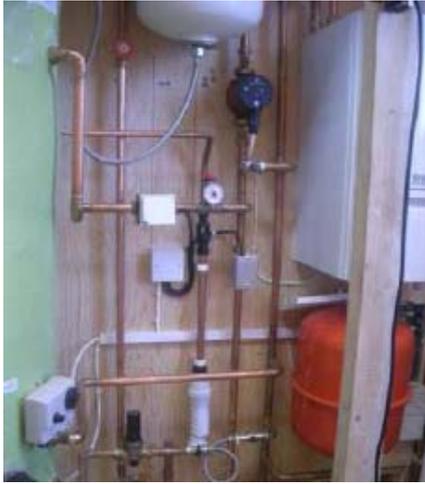
Figure 47: Solar ready HWC before additional insulation added. DHW pipes (not radiator pipework) were later insulated

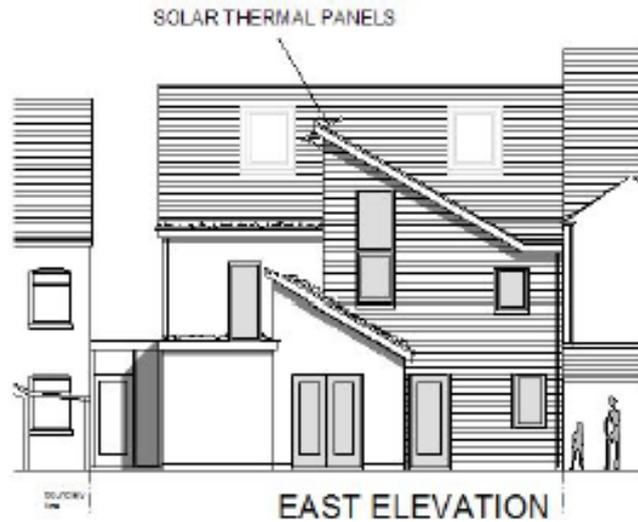
Figure 48: A platform for solar thermal panels has been mounted to the rear of the property

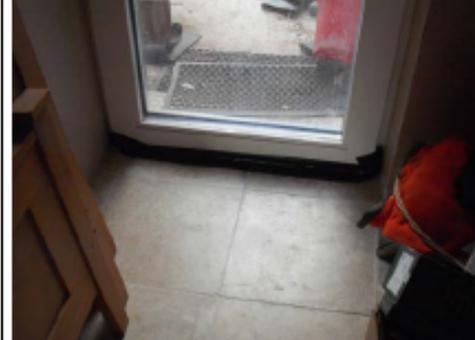
<p>Temporary seal across bottom of single door during final test.</p>		<p>Temporary seal across bottom of double door during final test.</p>

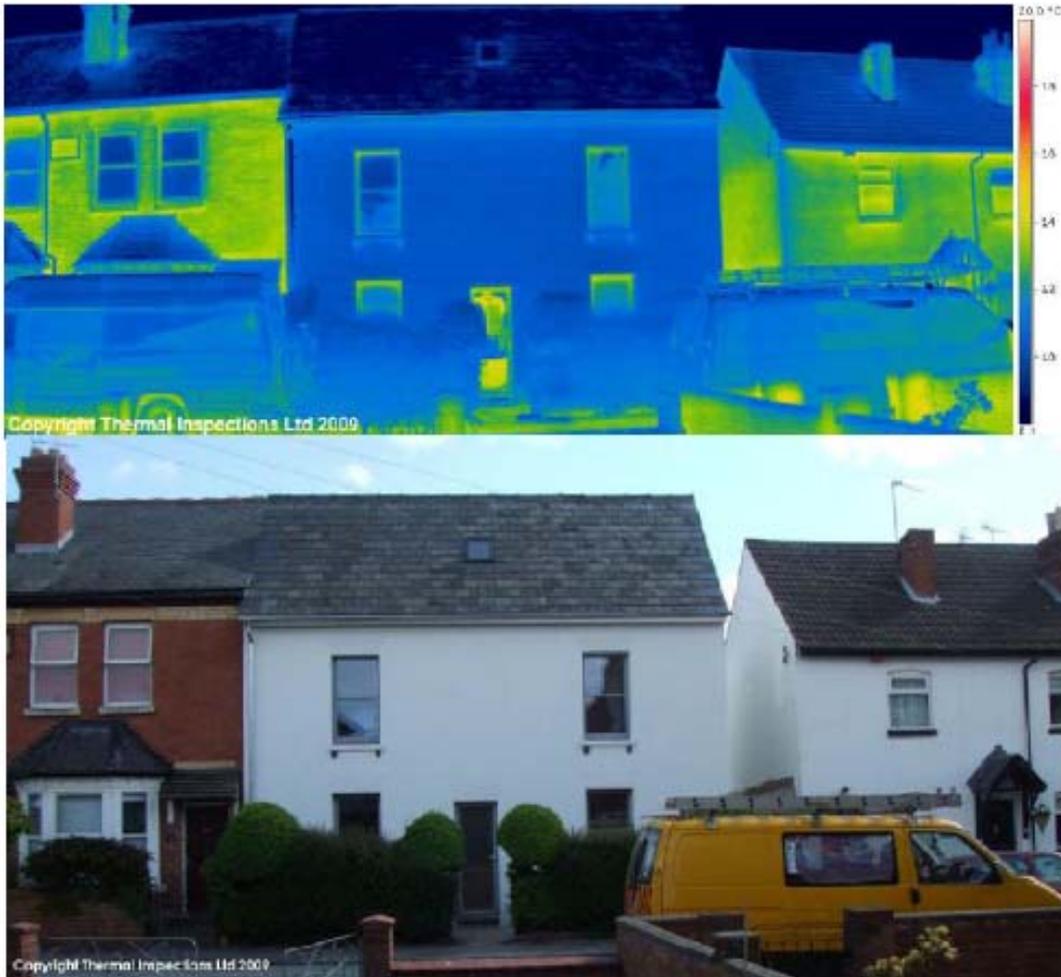
Figure 51: Thermographic image of Grove Cottage (centre)

Thermographic imaging showed that overall fabric thermal performance was excellent, with significantly reduced heat losses compared to neighbouring properties.
